**Final Report**  
**Santa Ana Watershed Project Authority**  
**Middle Santa Ana River**  
**Agricultural Land Use**

October 31, 2012

Prepared by:  
Aerial Information Systems, Inc.  
112 First Street  
Redlands, CA 92373  
(909) 793-9493  
[ais@aisgis.com](mailto:ais@aisgis.com)

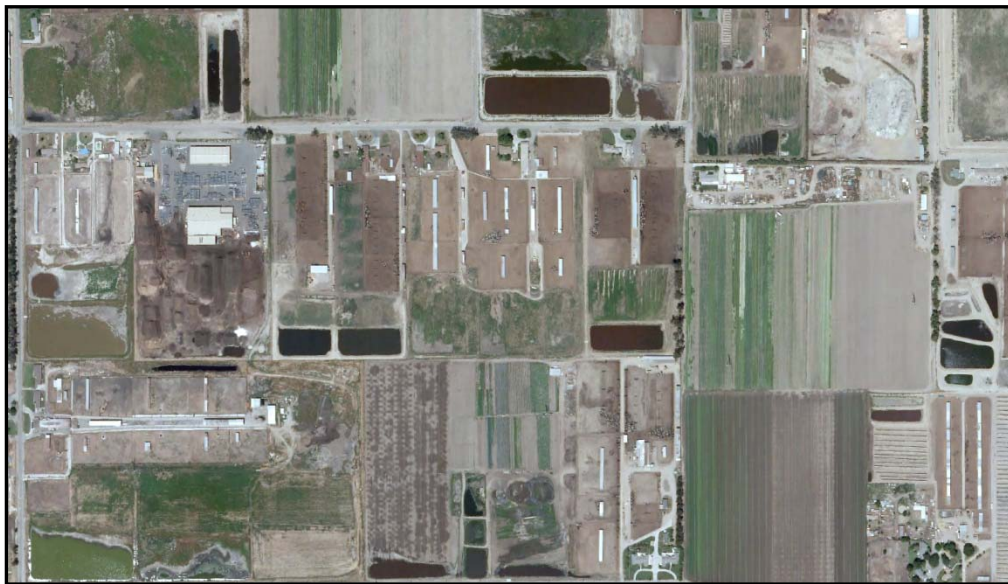
**Example of project imagery**

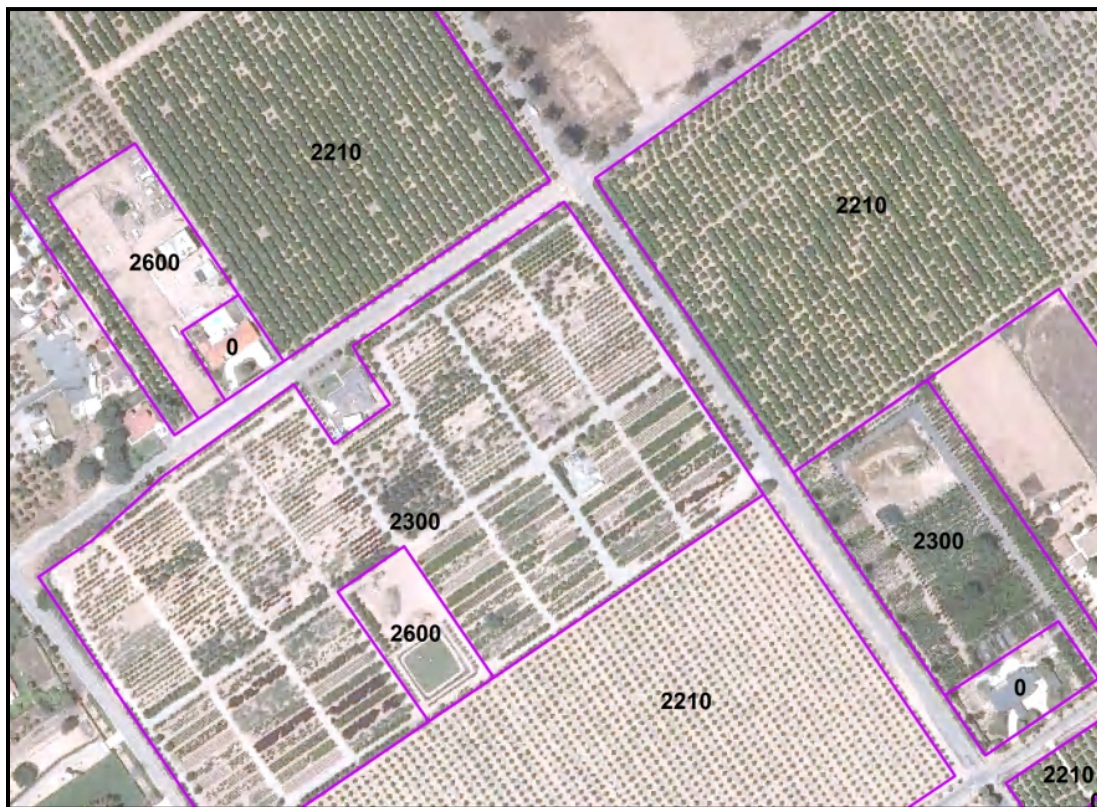
Example of AgLU polygons

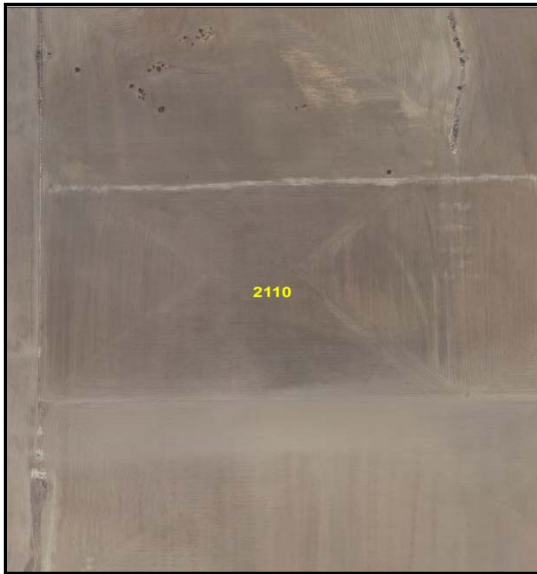
**Example of irrigated photo signature**

Irrigated cropland is easier to identify on the aerial photo if it is actively being irrigated at the time of the photography. Non-irrigated agriculture is more difficult to identify although certain inferences can be drawn, again based on the aerial images. For example, in Southern California the majority of rainfall occurs in the winter and early spring. If the aerial photos were flown during that time, it can be assumed that some of the actively growing crops are non-irrigated, although it is difficult to distinguish them from irrigated crops. Conversely, if the aerial photos were flown during the late summer, then it can be assumed that virtually all of the actively growing crops are irrigated.

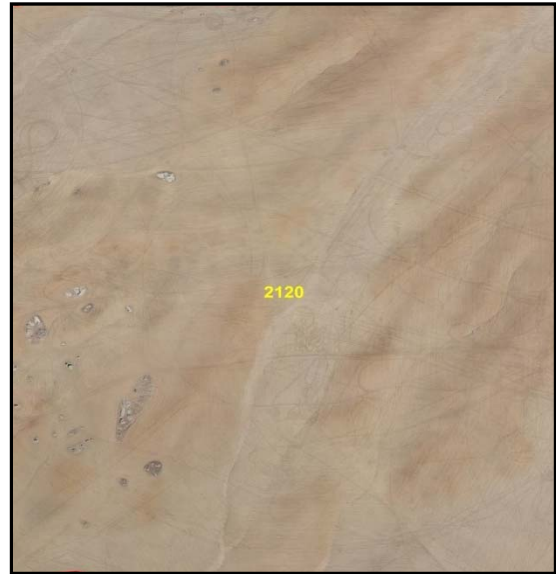
**Example of non-irrigated photo signature**

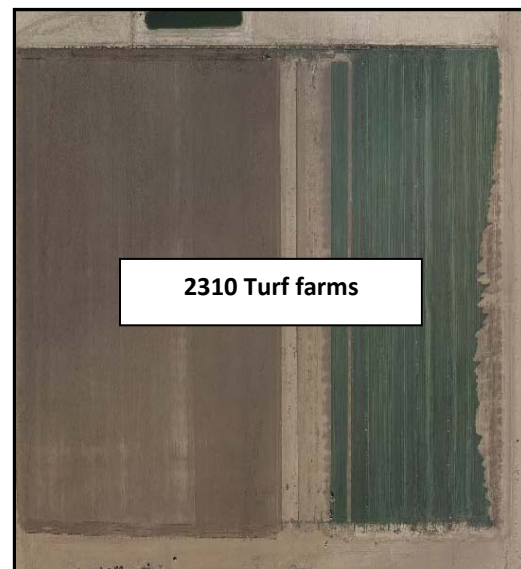
Similar issues affect the interpretations of the *2310 Turf Farms* and *2110 Irrigated agriculture* AgLU classes. At certain times during the crop-cycle of both, it's very difficult to tell them apart on the aerial photos (see examples below). Seasonal crop rotations are also an issue.

In order to consistently capture these three land use types, AIS followed the following mapping criteria:

1. If the photo signature showed an irrigated crop signature but the on-site field visit did not, or the field team observed irrigated crop being grown within the confines of a Turf farm, the polygon was coded for the irrigated crop.

2. Where the photo signature appeared to be non-irrigated but the field team observed evidence of irrigation, the polygon was coded as irrigated.
3. Where the photo signature appeared to be non-irrigated and the field team did not see evidence of irrigation, the polygon was coded as non-irrigated.

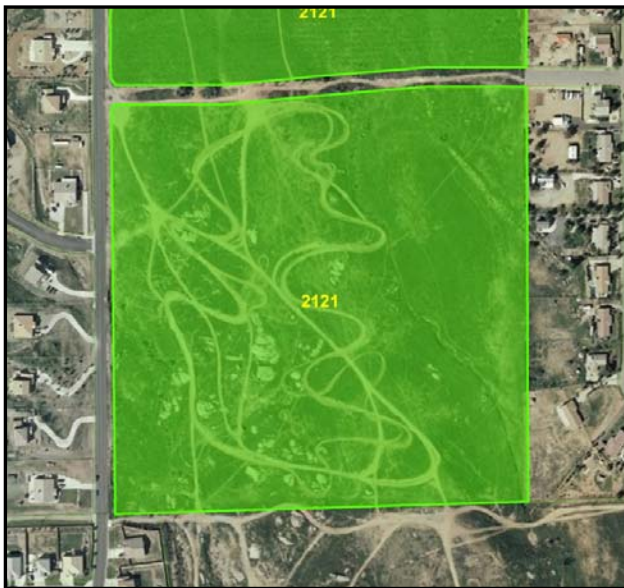
**AgLU with Zoning Data and Aerial Imagery**

mapped where the available city and county zoning maps showed areas designated as agricultural zones intersecting with vacant land on the aerial photos. In order for a parcel to contain a 2121 code, there must have been a minimum of 1 acre of “Vacant, Zoned Agriculture” within it.

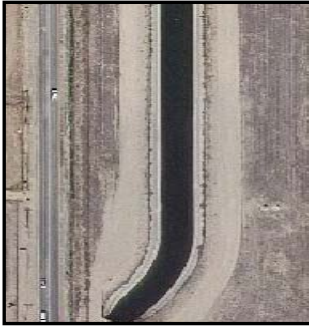
#### **1436 Water Transfer**

This category includes major above-ground water distribution channels, aqueducts, water treatment, filtration (non-sewage), reclamation (non-sewage), and pumping facilities. On the imagery, channels and aqueducts appear as linear features, with water flanked by light-toned concrete.

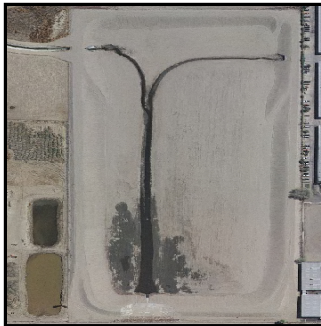
#### **1437 Flood Control**

This category includes improved flood control channels and dams, detention ponds, percolation basins, and debris dams.

Percolation/flood control basins are typically located adjacent to a flood control channel, or next to urban developments. The inlets are often visible as small concrete lined culverts with evidence of water drainage. Debris dams are normally earthen, but may contain a concrete spillway. They are located at the mouth of canyons or downstream of the canyon, and contain a vegetated, though dry to intermittent back pond. Dams associated with water storage are mapped as code 1434.

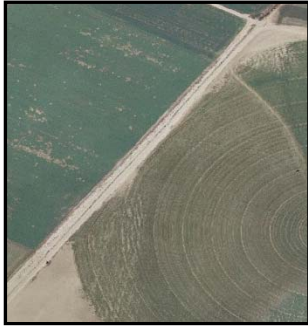
## 2110 Irrigated Agriculture

This category includes all irrigated field and row cropland areas, and irrigated improved pasture land.

The majority of row crops in southern California are irrigated. The photo signature for active cropland will show one of several signatures. If the land is in field crop, the signature will show a uniform, smooth texture area, with a green color. Land that is in row crop will appear similar to field crop, except the individual rows can be distinguished as narrow parallel lines. Land that is being made ready for crop or has been recently harvested will appear as a uniform, smooth texture of off-white to tan color representing the just graded or plowed field. Fallow fields will appear similar to vacant lots or disturbed vacant land. The area will appear unkempt, with a non-uniform texture representing a mixture of shrubs and grasses in a successional state. Fallow land will typically occur in close proximity to in-crop areas.

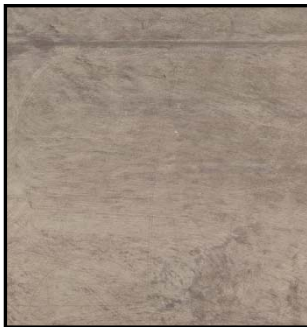
## 2120 Non-Irrigated Agriculture

This category includes all non-irrigated cropland, including dry-farmed field crops.

Depending on the time of the aerial photography, the photo signature for non-irrigated field crops can vary between a dull green to mottled brown color with smooth, uniform texture or display a uniform green smooth texture. Furrows or plow marks may also be visible. Dry farmed areas may appear very similar to natural grass vegetation. Land that is being made ready for crop or has been harvested will appear as a uniform, smooth texture of off-white to tan color representing the just graded or plowed field. Fallow fields will appear similar to vacant lots or disturbed vacant land. The area will appear unkempt, with a non-uniform texture representing a mixture of shrubs and grasses in a successional state. Fallow land typically occurs in close proximity to in-crop areas.

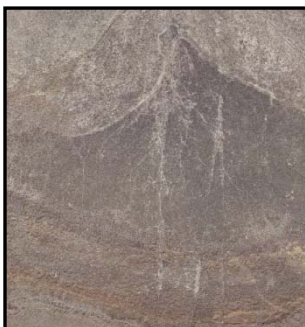
### **2121 Vacant, Zoned Agriculture**

This class requires existing zoning data in order to delineate the boundaries. Areas zoned as agriculture on the digital zoning data are compared to the aerial photo signature. Vacant (not fallow) areas as shown on the aerial photos that fall within the boundaries of an agricultural zone are classed as 2121.

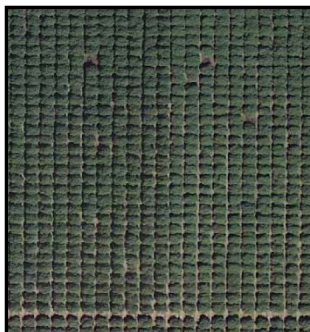
### **2210 Citrus**

The photo signature for citrus orchards is typically a dark green, coarse-textured area, where the individual trees are distinguishable. The trees are aligned in a matrix form, with crowns appearing to abut each other.

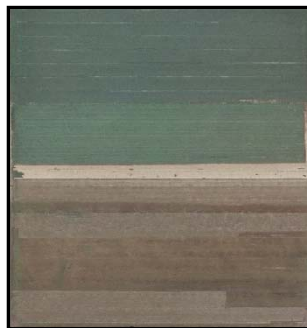
### **2310 Turf Farms**

On the aerial photo, turf farms appear similar to pasture or field crop; therefore, some field verification is necessary. Actively growing turf usually appears as an extremely smooth uniform green signature with occasional strips of bare ground showing where the turf has been harvested.

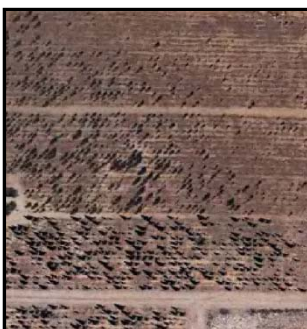
### **2320 Christmas Tree Farms**

Christmas tree farms often appear on the imagery as unevenly planted groves containing plants of various sized crowns and separated by varying amounts of open space. This effect is created by differences in the planting and harvest cycle over time.

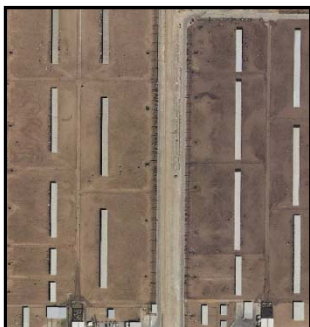
#### **2411 Dairies – Intensive**

This class describes the main operating area of the dairy, including confined feeding area and corrals, typified by a dark, wet looking, earthen signature. Large numbers of cows are often visible. Feeding troughs, hay storage, and shelters are usually present. Intensive areas of the dairy usually contain simple rectangular shade structures that are evenly and widely spaced over the area. Structures for protecting stored hay bales may be present, in addition to structures used for milking. All dairies should have at least one area defined as intensive. Manure piles visible on dairies are not mapped separately.

Livestock feedlots and dairies appear similar in that both contain a series of small fenced areas with a very high concentration of animals. Both feedlot and dairies contain fenced areas with a very dark to black photo signature representing dung piles. Pasture and field crop adjacent to and associated with dairies are mapped as 2412.

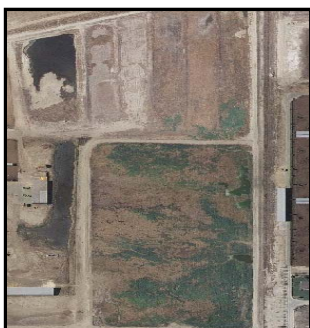
#### **2412 Dairies – Non-Intensive**

This class describes the pasture area and other non-livestock intensive areas of dairy operations. The photo signature usually includes large fields adjacent to the main operating area of the dairy. The fields often look vaguely plowed and can include irregular shaped areas of water and larger fenced pastures. Not all dairies will have a non-intensive

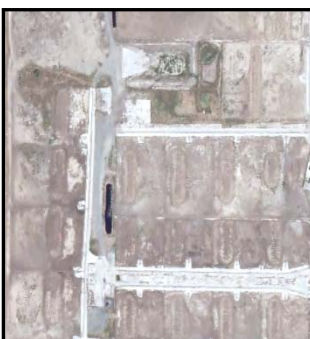
#### **2413 Abandoned Dairies**

This class describes dairies that have obviously been abandoned but have not yet been converted to other uses or gone back to vacant land. The photo signature will typically show building footprints and sometimes even standing structures. There is usually no evidence of active animal husbandry. Associated ponds are usually dry and surrounding pastures exhibit an unkempt appearance.

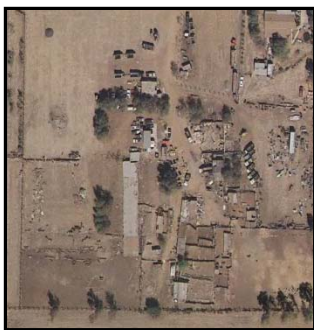
## 2420 Other Livestock

This category includes large, specialized livestock and other specialty farms. These areas have a high concentration of animal population in a relatively small area. This class includes pig, goat, llama and other non-cow livestock farm uses. It also includes areas where there is evidence of livestock in a non-intensive setting, e.g. fenced pastures, corrals, shelters, but very few to no animals visible.

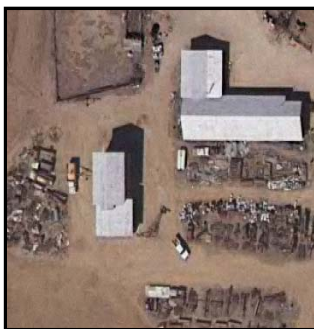
## 2600 Other Ag Undifferentiated

This category includes other miscellaneous agricultural facilities not described in the agricultural categories above. These facilities include storage facilities, hydroponic farms, fish hatcheries, apiaries, and worm farms. Storage facilities can include isolated barns, or other structures located in, or adjacent to an agricultural area. Also included are small plots of land where heavy equipment or machinery is stored within the agricultural field area. Track ovals not associated with an equestrian facility (2700) are coded 2600.

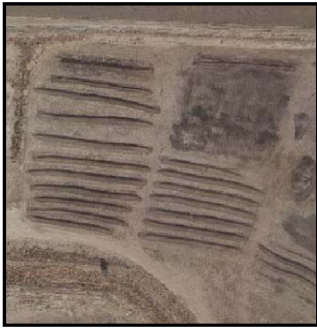
## 2610 Manure and Compost Piles

This category includes all manure piles located outside of dairy farms, including areas identified as potential unauthorized dumping grounds. Compost and green-waste piles are also included in this category.

Areas of unauthorized manure dumping typically do not reflect the classic manure photo signature due to the temporary nature of the piles, as the operators quickly disperse the piles in order to avoid detection. On-site field observation is required and then the interpreters can back-track the known location to a potential photo signature. On the photos, manure spreading areas can look like fields that are being prepped for imminent agricultural planting due to the dark, freshly tilled look of the soil.

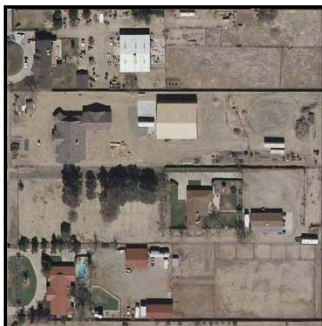
## 2620 Backyard Livestock

This class is intended for areas that are predominantly residential – typically suburban and semi-rural locations. For situations where animals are observed in a non-residential setting, the 2420 *Other Livestock* class was used.

Backyard agriculture may include improved pastures, barns, and/or corrals. This class is mapped for contiguous areas of backyard animals, including horses, goats, pigs, chickens, etc. In the Norco and Hemet areas, many of the lots are 10, 5, and 2.5 acres. Small isolated residences are not important, but a concentration of houses, each with backyard livestock, can have a significant impact in terms of run-off water quality.

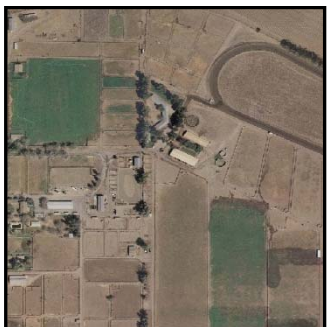
## 2700 Horses

This category includes commercial and non-commercial horse ranches, stables, tracks, barns, and corral areas, and improved pastureland. Commercial horse racing track facilities are not mapped as part of the AgLU.

In general, irrigated agricultural fields within the horse farm area are mapped as 2700. However, extremely large areas of irrigated agriculture within the farm will be mapped are captured as 2110.

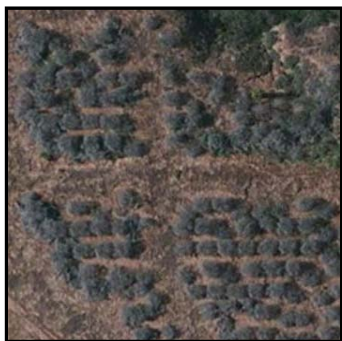
## 3200 Abandoned Orchards/Vineyards

This category includes formerly productive orchards and vineyards that are now abandoned and not in commercial production.

Abandoned orchards and vineyards may contain successional or weedy vegetation between the rows. The photo signature may show and the field check may verify an unkempt condition. Many trees or vine plants may be dead, or totally removed. If a significant number of trees remain on the lot, then the polygon is coded 3200. If most trees have been removed, then the polygon is considered vacant and is not captured as part of the AgLU.

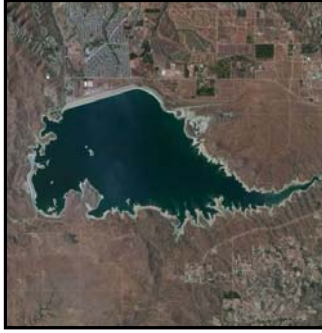
#### **4000 Water**

This category includes all perennial open water bodies greater than 1 acre in area not associated with water storage; and all water bodies associated with water storage that are greater than 5 acres in size. Included in this class are oceans, lakes, reservoirs, golf course ponds, rivers, estuaries, and channels.
