Tier 2 Arlington Area Bacteria and Flow Source Investigation

Technical Memorandum

SAWPA MSAR TMDL Task Force

January 2018

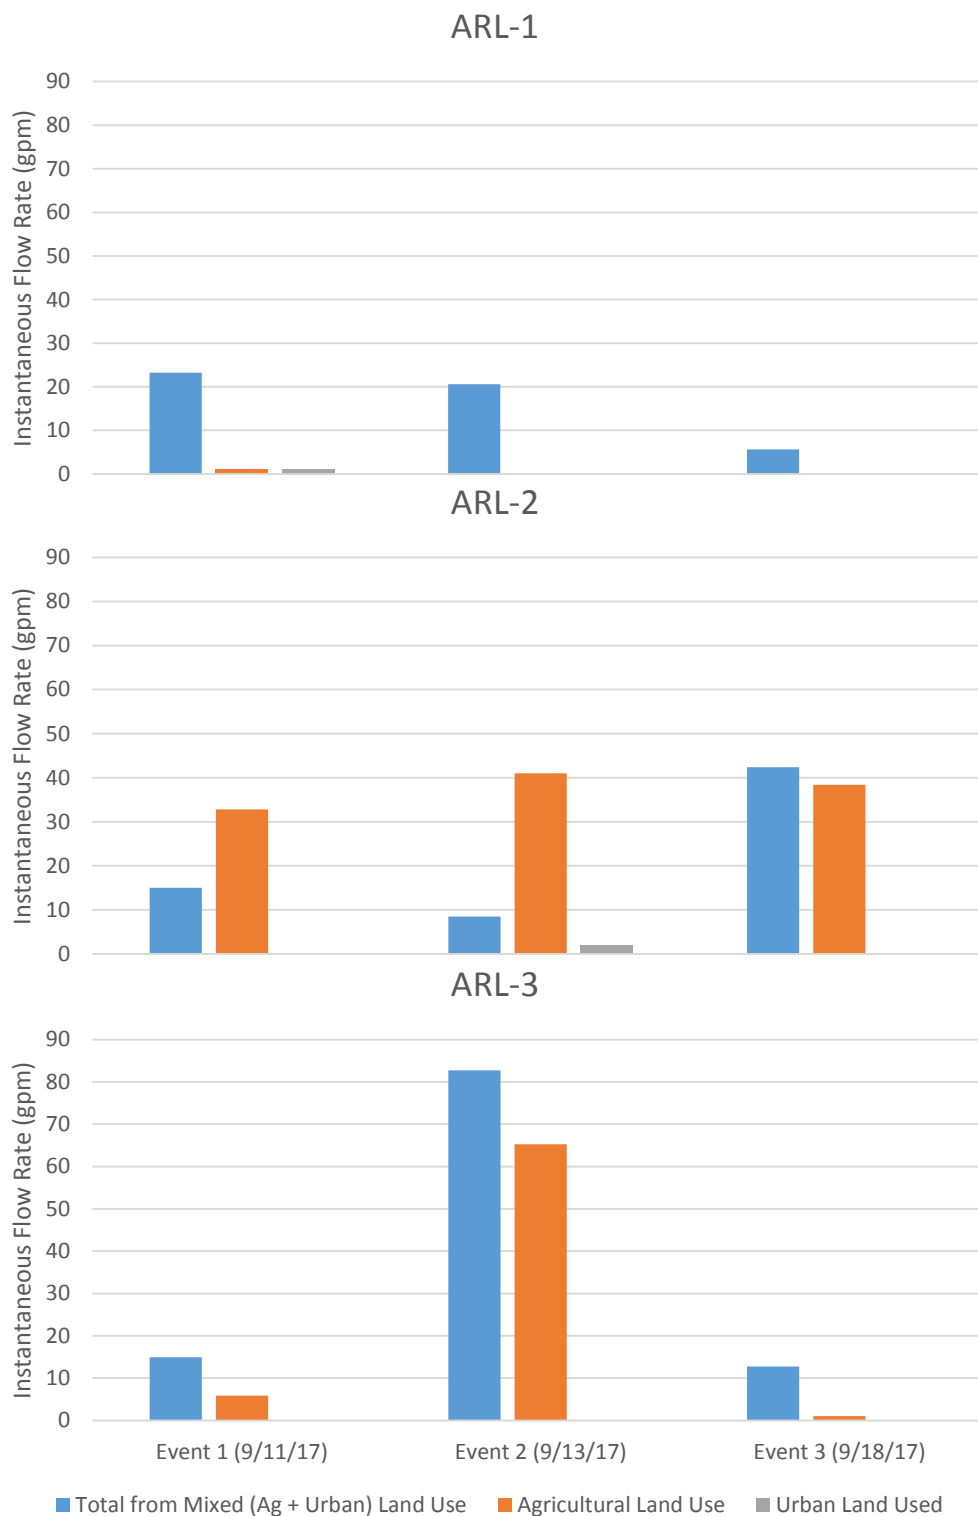
Figure 5. Flow Comparison by Land Use

As summarized in Figure 5, flows at upstream agricultural inputs were often attributable to agricultural grove irrigation. The intermittent nature of irrigation sources of flow, compared with the persistent nature of flow at downstream inputs to the Monroe Retention Basin, suggests that some flow may be originating from sources yet to be characterized, such as residential irrigation, additional illicit discharges, groundwater, or illicit connections. Additional data are needed. However, when flows from agricultural inputs (grove irrigation) were actively occurring, they did contribute most of the flow observed at the downstream input to the Monroe Retention Basin for the ARL-2 and ARL-3 subdrainage areas, which represent the majority of flow to the Monroe Retention Basin.

Note: Where agricultural instantaneous flow rates exceed mixed land use instantaneous flow rates, this does not necessarily represent infiltration, detention, or evaporation. Rather, the flow rate may attenuate as the flow moves downstream. Cumulative flow comparisons from paired continuous flow data collection will provide more quantitative and accurate comparisons.

Of the nine instances of flow (or recent flow) observed at the five agricultural input monitoring locations with intermittent or persistent flows, six of the sources were tracked to their origin and were confirmed as grove irrigation (Attachment A). Two samples had unidentified sources; grove irrigation was suspected because of the quantity of flow and general origin, but could not be confirmed in the field because the private property was inaccessible (Attachment A). One sample (ponded) was suspected to have originated from residential over-irrigation, based on evidence of recent flow (Attachment A). In the urban land use area between the agricultural inputs and the Monroe Retention Basin, residential over-irrigation was observed to be actively contributing to downstream sites during one instance. Preliminary assessment of relative contributions from different source types to the Monroe Retention Basin is summarized in Figure 5.

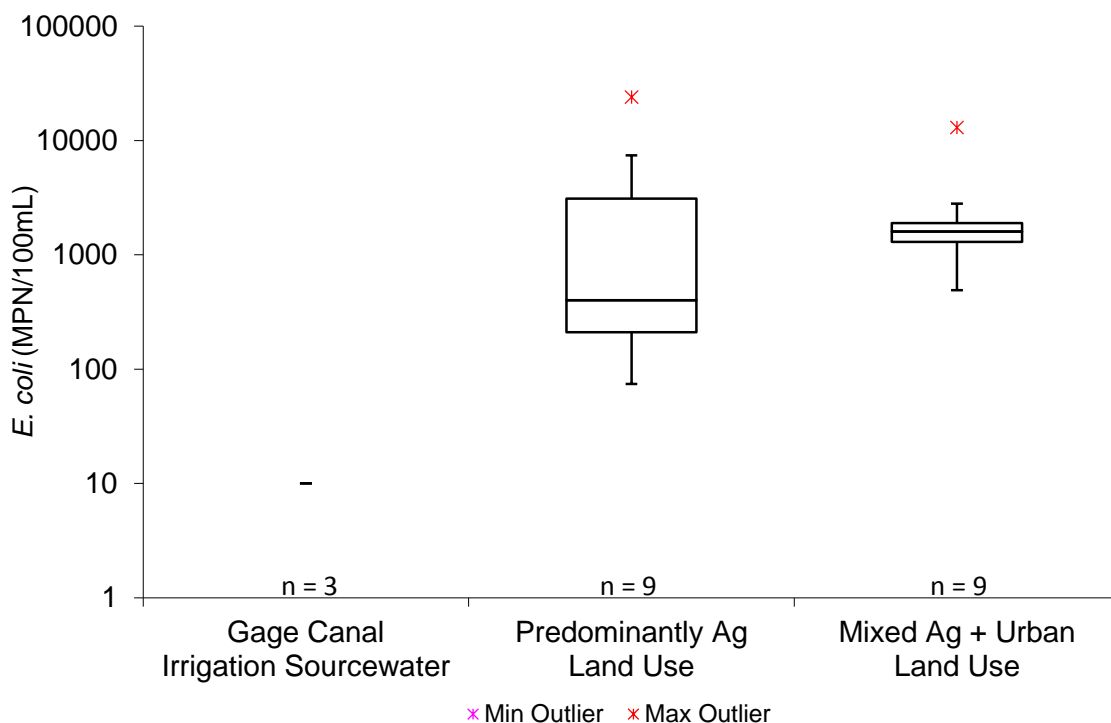
Figure 3. *E. coli* Concentrations by Land Use Type

Note: The box represents the interquartile range (IQR). The ends of the whiskers are set at 1.5*IQR above the third quartile and below the first quartile. Outliers are outside of this range.

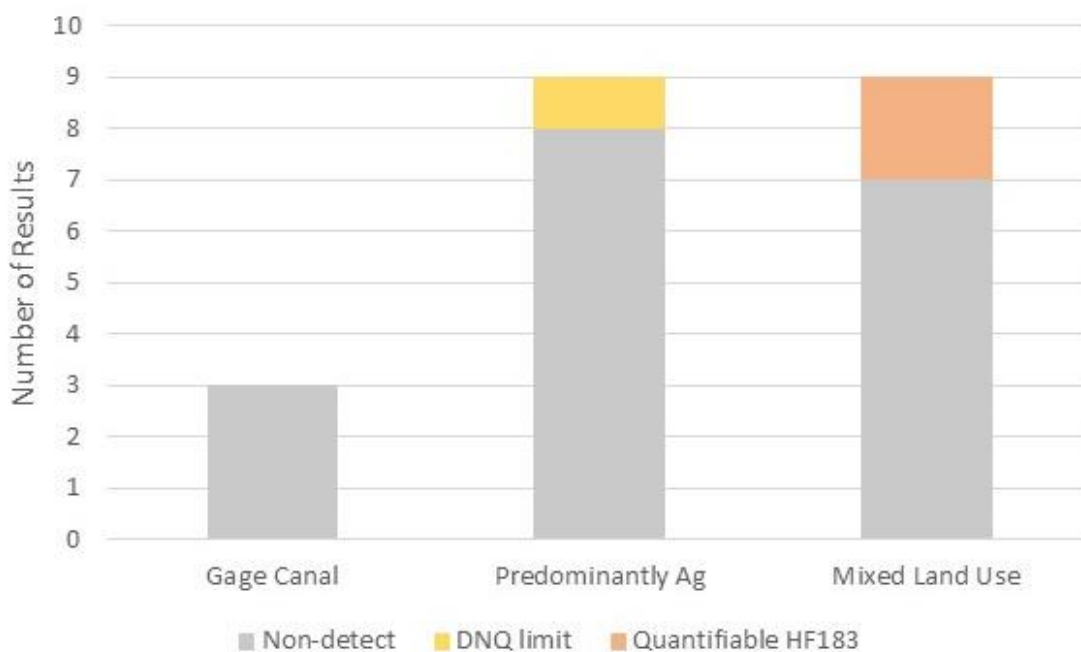
Figure 4. Summary of HF183 Results by Land Use Type

HF183 was not detected in most (19 of 21) samples. Two samples with HF183 were low level (133-266 copies per 100mL) and recorded at mixed land use sites. For reference, HF183 concentrations in raw municipal sewage are typically greater than one million (>10⁶) copies/100mL. These low level detections may indicate the presence of a human source in the urban land use portion of the drainage area (e.g. leaking sewer infrastructure), or a false detection due to a cross-reaction from an animal source (e.g. chicken or dog). Because low-level human signals still have the potential for public health significance (SCCWRP, 2017), it is appropriate to investigate these low-level detections as a conservative measure. No agricultural sites had quantifiable HF183. Attachment C provides *E. coli* and HF183 concentrations associated with each sample collected. Figure 4 provides a summary of HF183 results by site type.

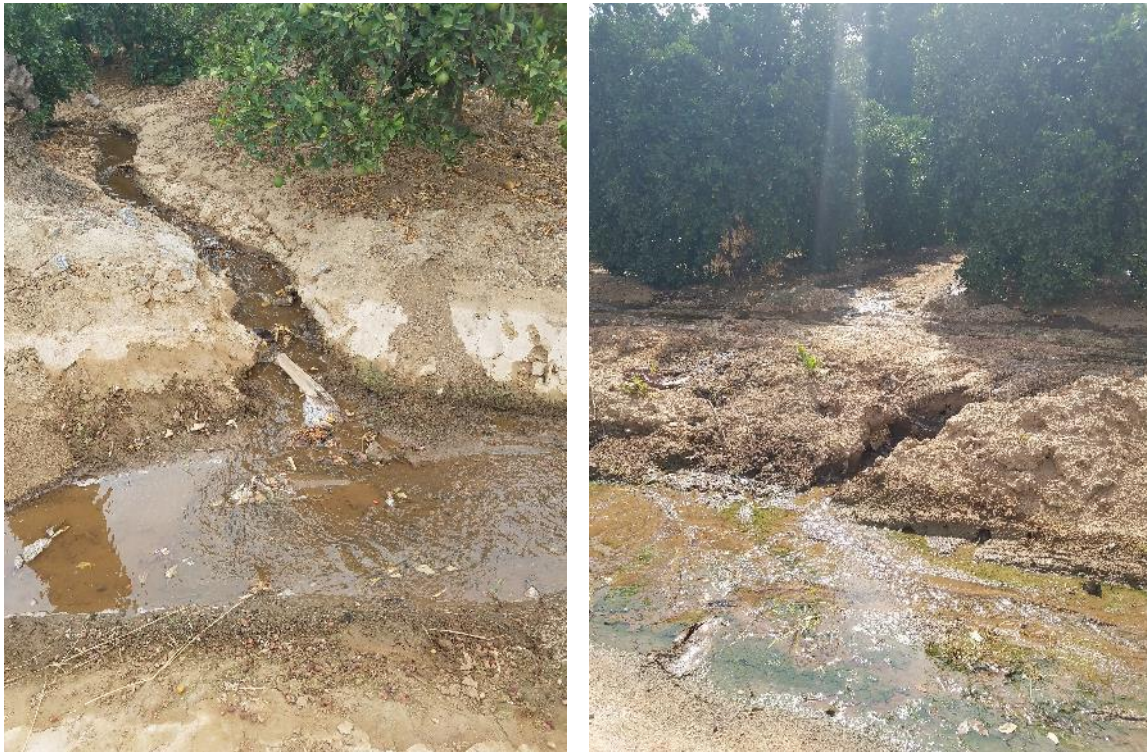
Figure B-15. Grove Irrigation

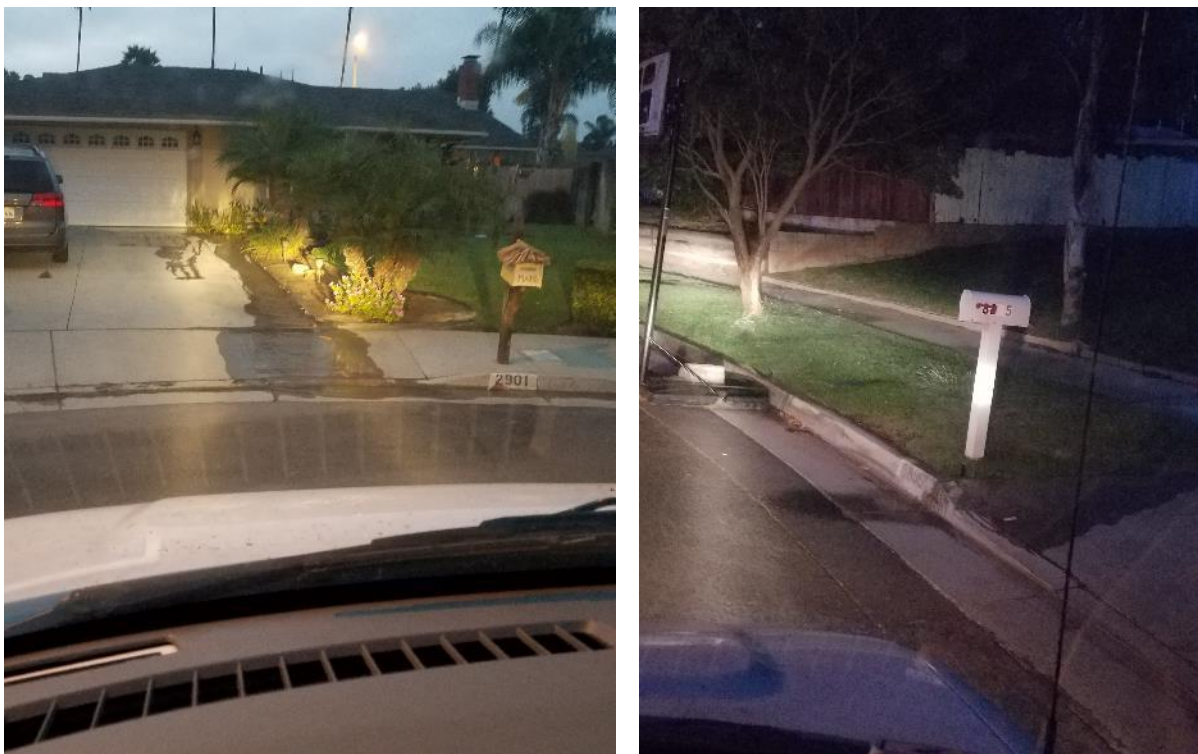
Figure B-16. Residential Over-irrigation

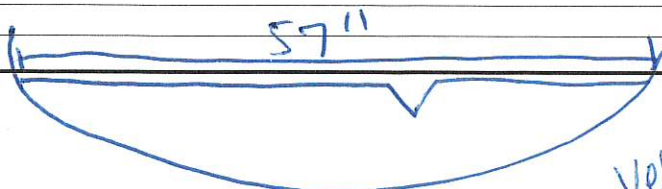
Flowing through
notch but
over edges
of weir
as circles

13.5 in above sensor (water depth)

5 ft
pipe

Vel = 1.14 fps
at fastest flow

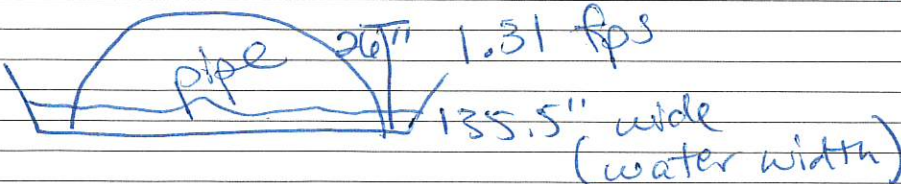
Flow is above brown flow lines on edges of channel

Diagram labels: pipe, 20", 1.31 fps, 135.5" wide (water width), 144", 42", 60"
