Lake Elsinore and Canyon Lake TMDL Water Quality Monitoring Update – 2017-18 Summary

September 19, 2018

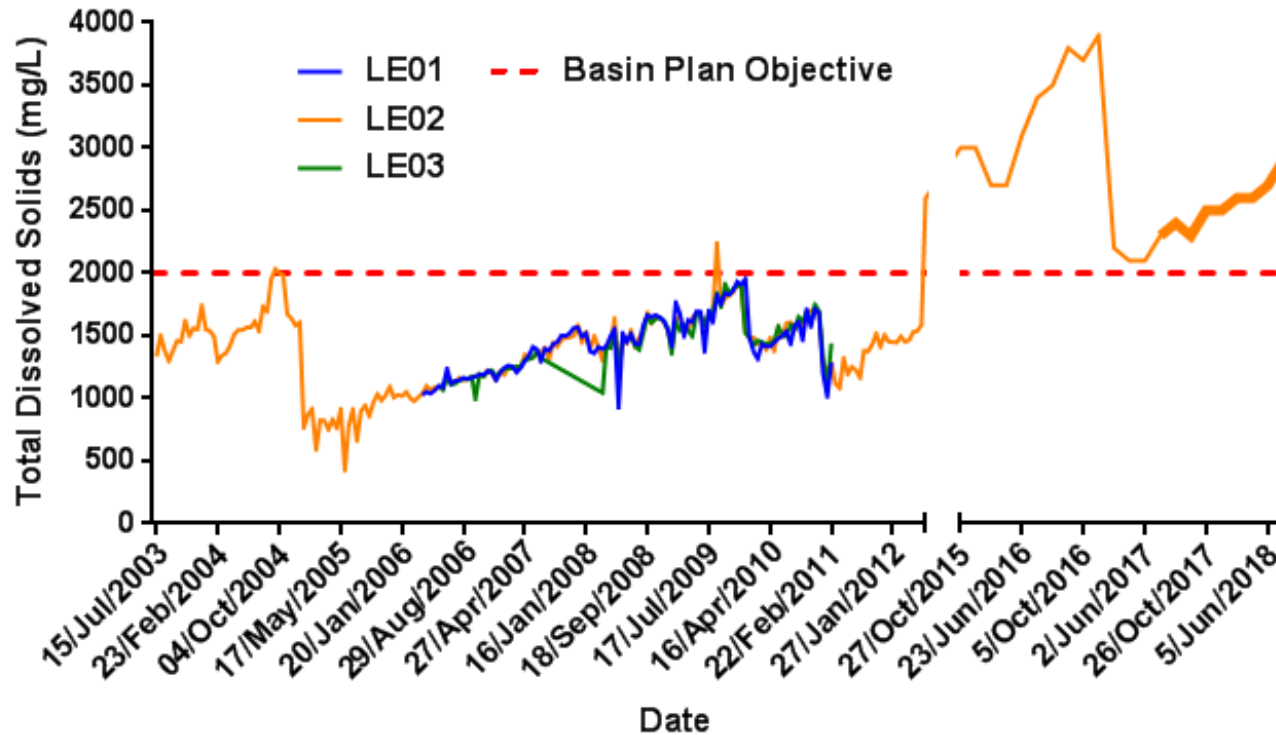
Total Dissolved Solids– Lake Elsinore Historic Data

No data available from June 2012-July 2015

Bold represents current monitoring year July 2017-July 2018

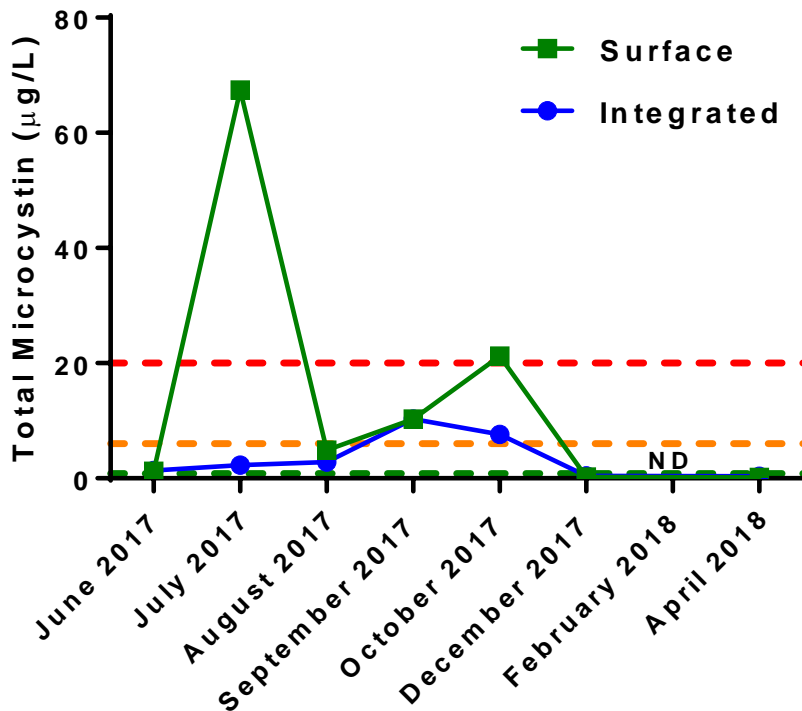
Total Microcystin – Lake Elsinore 2017-2018 (LE02)

State CyanoHab Guidance Trigger Levels for Human Water Contact

- Danger = 20 µg/L
- Warning = 6.0 µg/L
- Caution = 0.8 µg/L

* Cyanobacterial toxins not sampled in June 2018
